CENTAUR AC-4 NOSE FAIRING JETTISON TESTS

by Jack C. Humphrey
Lewis Research Center
Cleveland, Ohio

Abstract

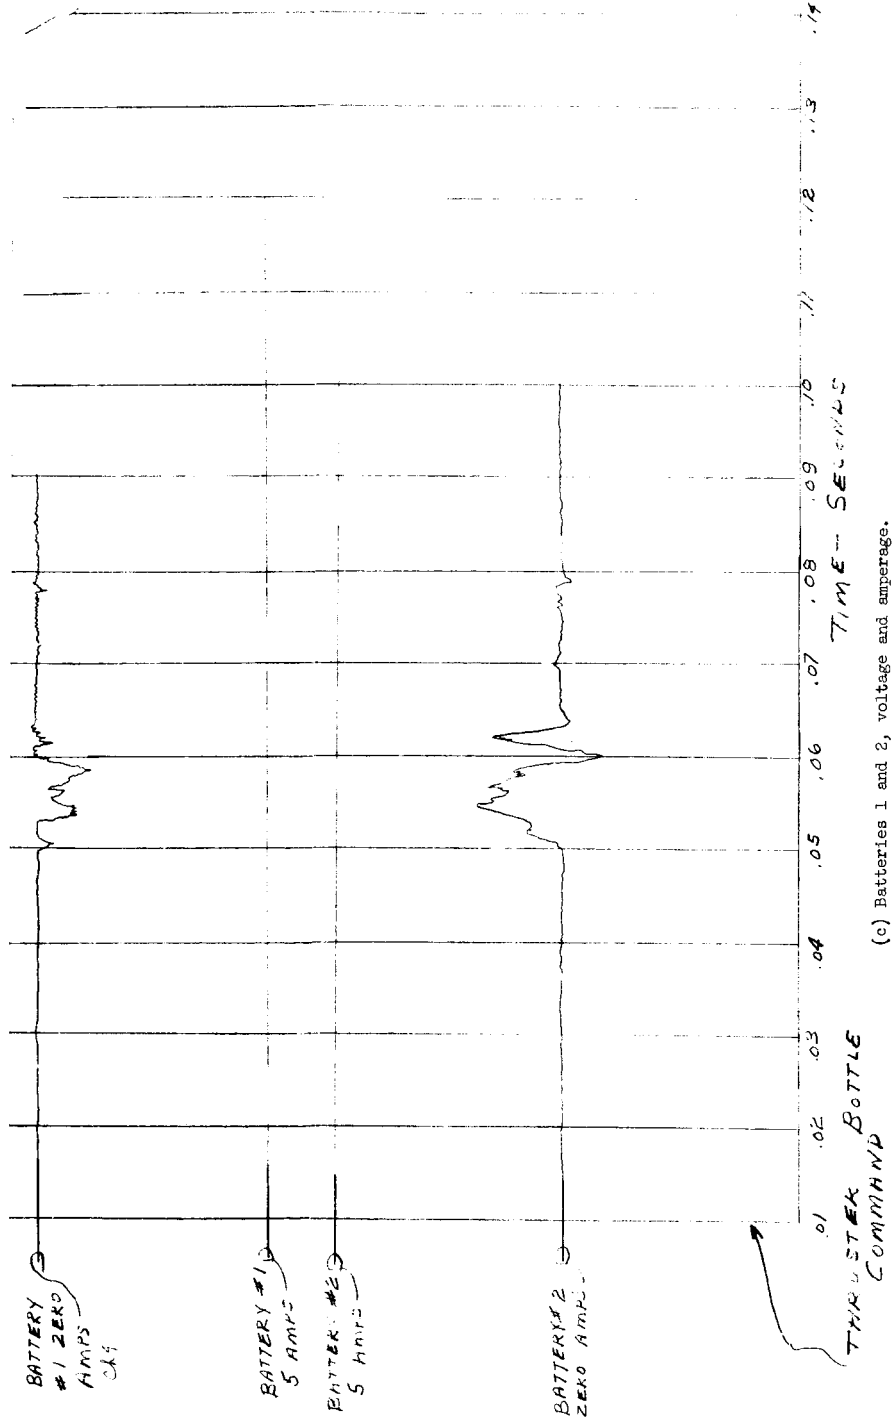
(c) Batteries 1 and 2, voltage and amperage.

The voltage and total current from the two AC4 flight type batteries are shown for tests 7 and 8 in figures 28 and 33. These batteries have a 35 volt no load level and will supply 0.5 amp hours of current. The voltage from each battery dropped from 5 to 7 volts for approximately 0.1 second and then returned to its starting voltage (35 volts). Current drain varied from 10 to 19 amps per battery. In no case did the batteries go below the minimum voltage level of 25 volts specified for a 20 amp load. Checkout of the pyrotechnic electrical circuits should be carefully done with devices having enough internal resistance so that the thermal overload relay in the circuit is not actuated.

Figure 33. - Continued.

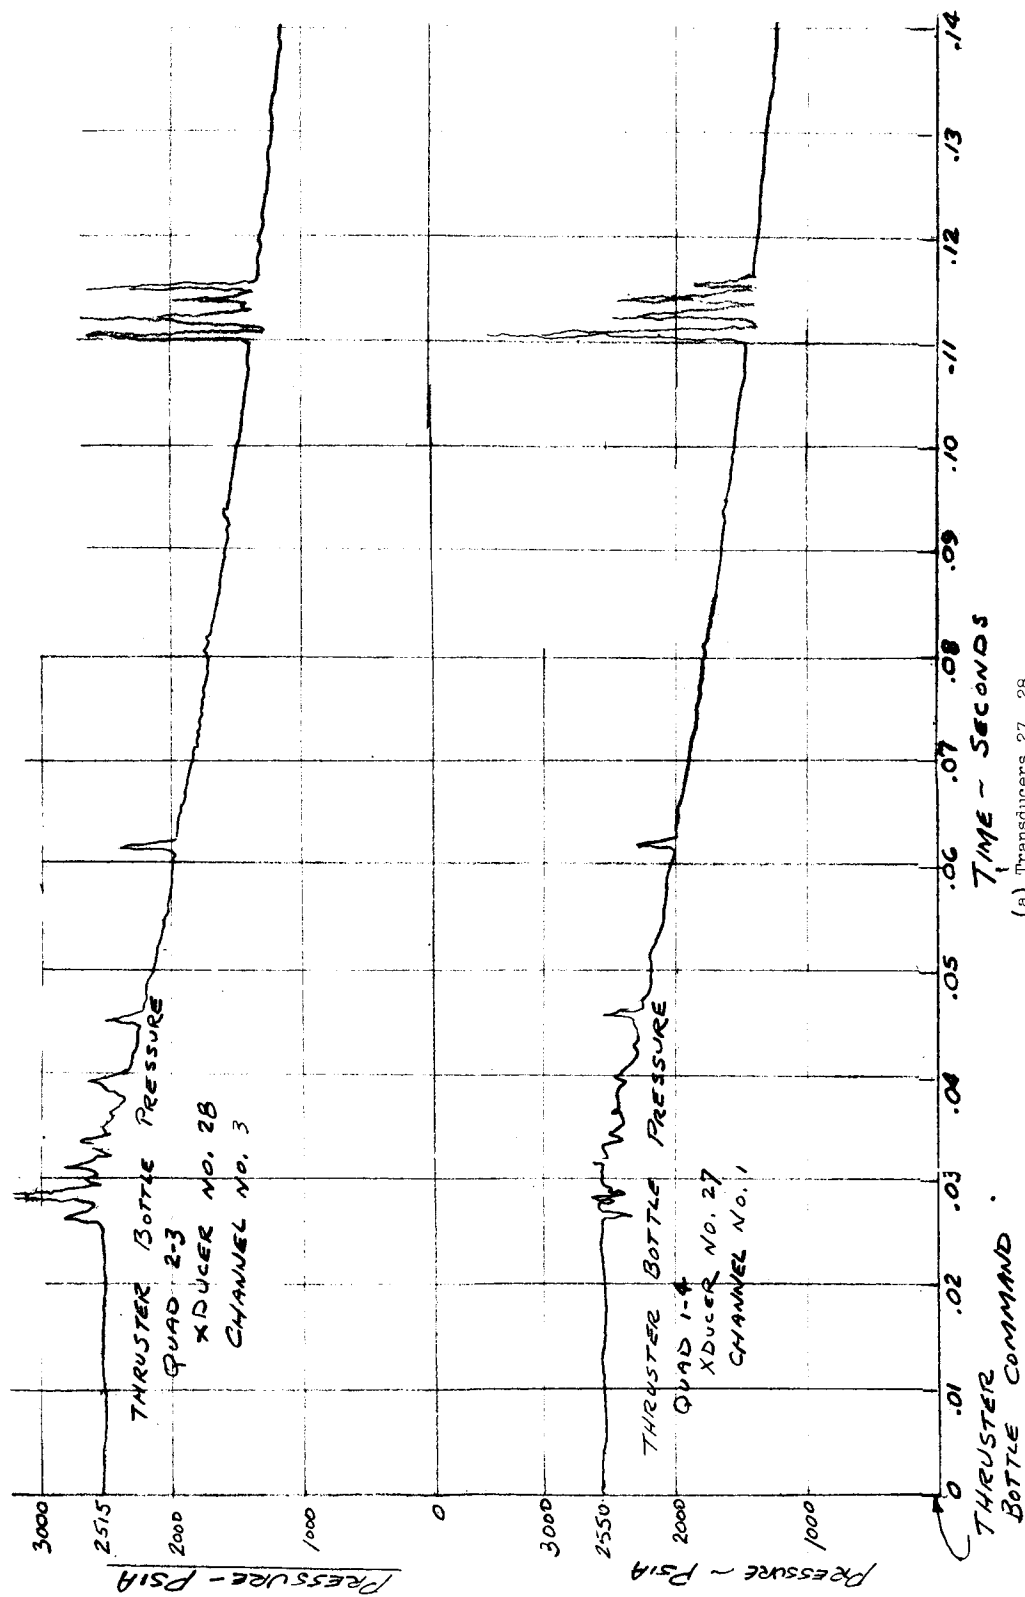
Figure 40. - Arcing on electrical disconnect fitting.

New flight type relays and batteries were used on this test. The 0.828 diameter orifice insert was installed in the thruster bottle nozzle. Explosive bolts and bolt fairing were again installed except that no bolt or fairing was installed at the bolt housing located at the joint between the cone and barrel section of the quad III-IV split line due to the fact that only seven bolt assemblies were available. The electrical signal for actuating the explosive bolts was again made by the program timer 0.52 seconds before jettison. Measurements were made of the clearance between the bottom of the barrel section channel and the top of the 219 ring. These clearances are shown on figure 39. Nose fairing jettison was accomplished with no evidence of contact between the fairing and the Centaur forward bulkhead model. Two struts on the II-III fairing half were damaged again and the electrical disconnect on the I-IV fairing half showed evidence of arcing. Damage to the struts was caused by separation inertia forces and not collision with catcher pads. Noise was recorded on all channels of the F/M tape recorder at approximately the time that the disconnects were separated and four of these channels were rendered un-useable. Figure 40 shows physical evidence of the arcing on one half of the disconnect fitting.

Inasmuch as much of the hinge strain gauge data was lost during test 10 due to arcing of the pyrotechnic electrical system on disconnect, it was decided that for test 11 a facility type electrical system with batteries, relay assemblies and power supplied by the facility for igniting the thruster bottle pin puller would be used. The explosive bolts were not installed for this test. Two strain gauges were installed on each of three struts, and a testing machine calibration of four of the strain gauges is shown figure 43. This calibration agreed closely with strains calculated from the manufacturer's strain gage factor.

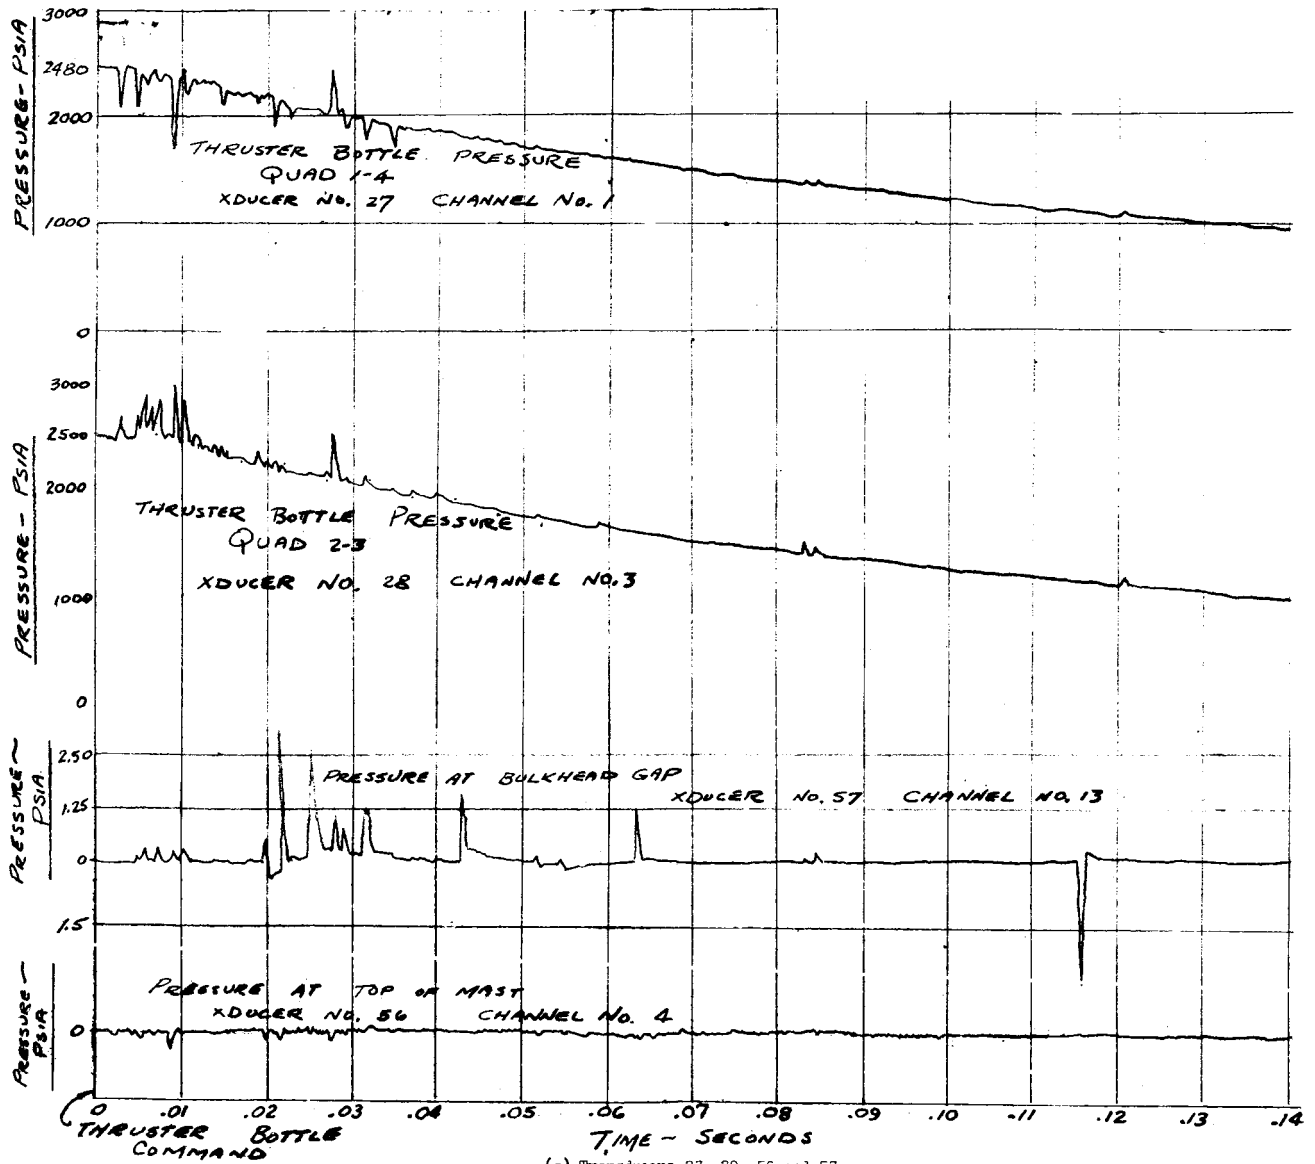
Figure 44. - Strut damage, Test 11.

For this test a successful jettison was obtained with the only damage on the fairing being limited to one strut on the II-III fairing half at the YY axis. Figure 44 shows this damage. Movies taken during the separation clearly show that this failure was caused by vibration of the thermal bulkhead during separation and not upon collision of the fairing with the catcher pad.

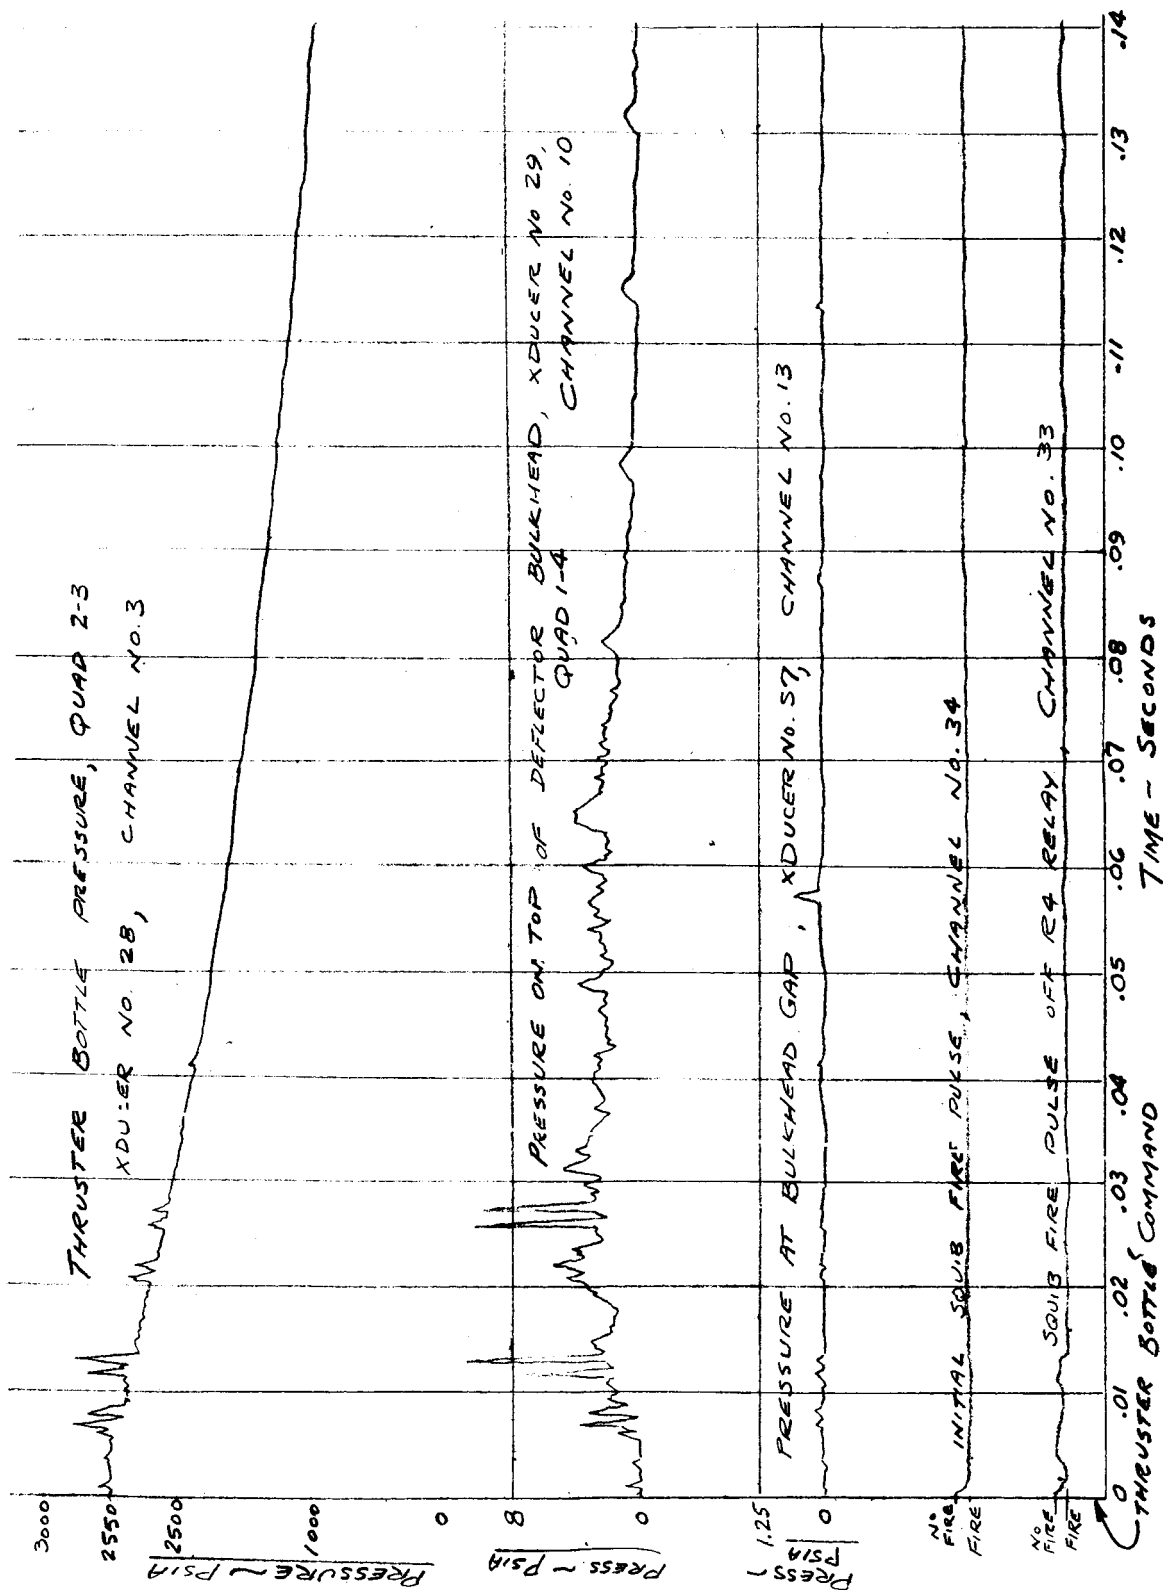
Figure 47. - Modeling clay on top guidance platform test 12.

Tests with modeling clay on the guidance platform mount during test 12 showed that the thermal bulkhead contacted the top of platform mount. The location of the clay after the test is shown in figure 47. Modification of the bulkhead was made before test 13 to the final AC-4 configuration as shown in figures 51, 52, 53, 54, and 55. The guidance platform mount and autopilot programmer were located on the equipment shelf as shown in figures 56 and 57. Toothpicks were installed on both the guidance platform mount and the autopilot programmer as shown in figures 57, 58, 61 and 62. From the length of the unbroken toothpicks after the tests it was apparent that a clearance of 1.0 inch on the guidance platform mount and 0.3 inch on the autopilot programmer existed during jettison.

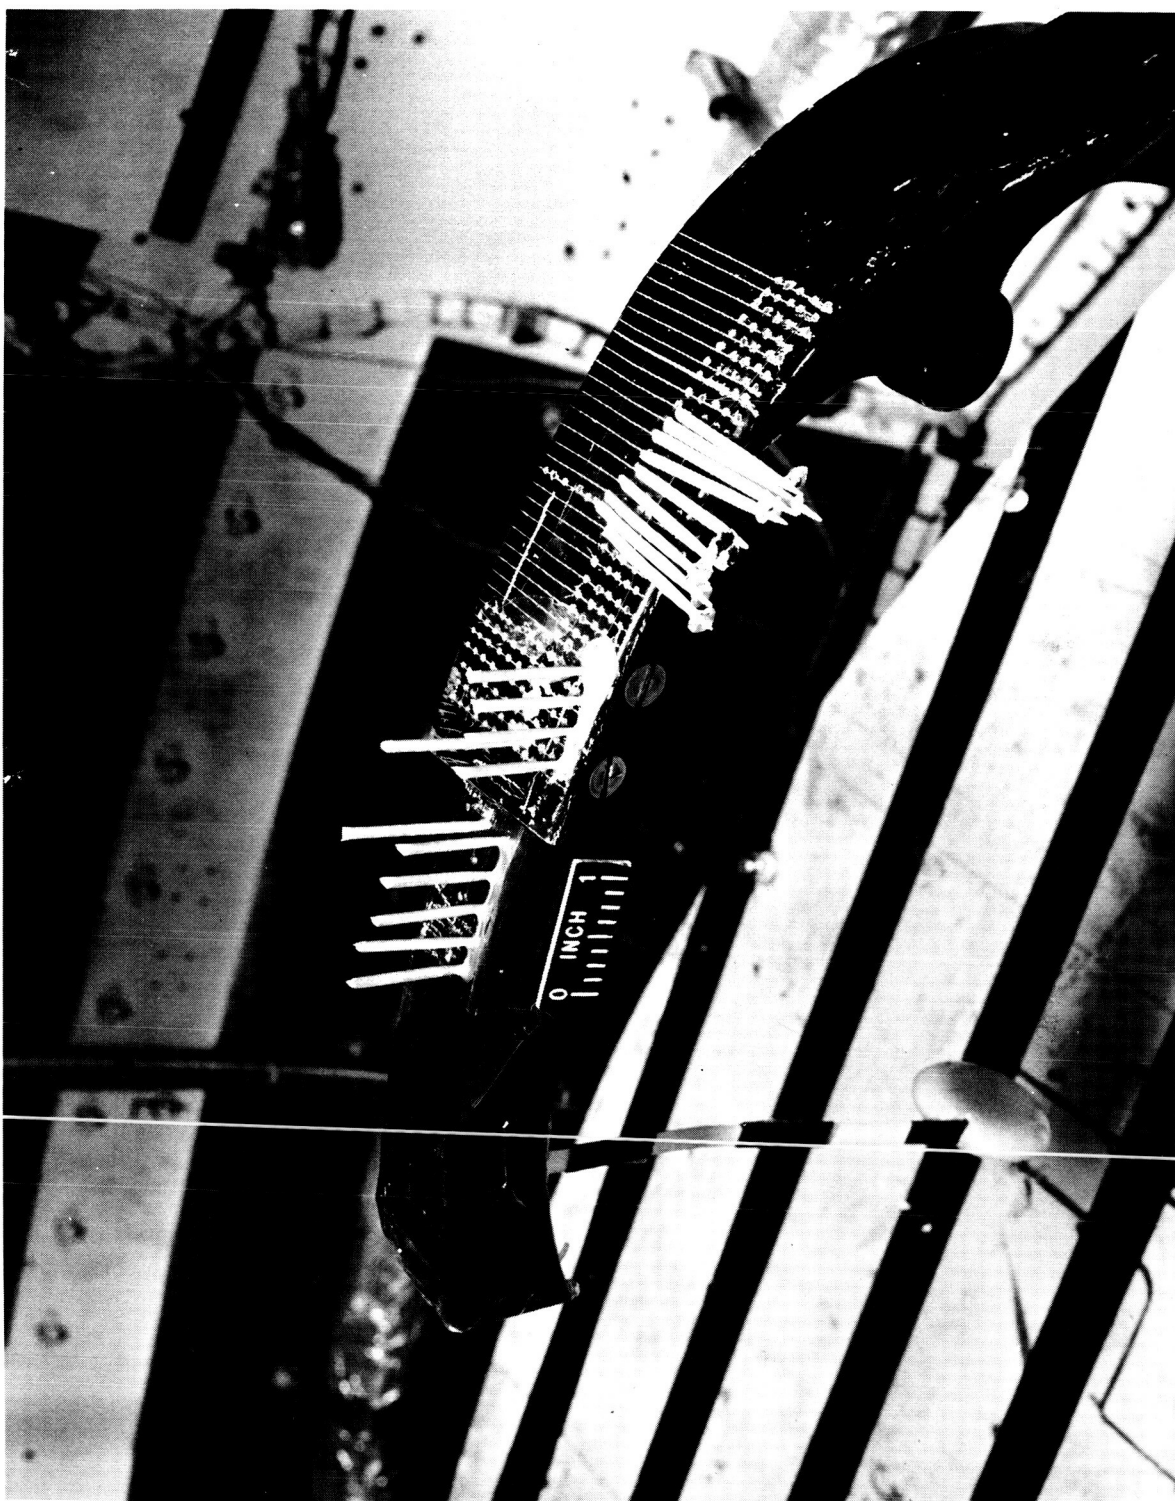
Figure 61. - Toothpicks on guidance platform after test 13.

Separation was successfully accomplished. One strut was bent as shown in figure 60. Examination of data revealed this damage occurred after fairing contacted the catcher plate. Toothpicks on both the Guidance Platform mount and the A/P programmer were broken but the remaining shorter toothpicks showed that sufficient clearance existed between the bulkhead and the packages. Minimum clearance as shown by toothpicks was 0.3. Figure 61 and 62 show the toothpicks, that were undamaged. Figure 63(a) through (f) shows the raw data and figure 64(a) through (c) show the trajectory.
